Point Wells Development

Preliminary Short Subdivision Submittal

Targeted Stormwater Site Plan Report

February 14, 2011
Revision April 24, 2018

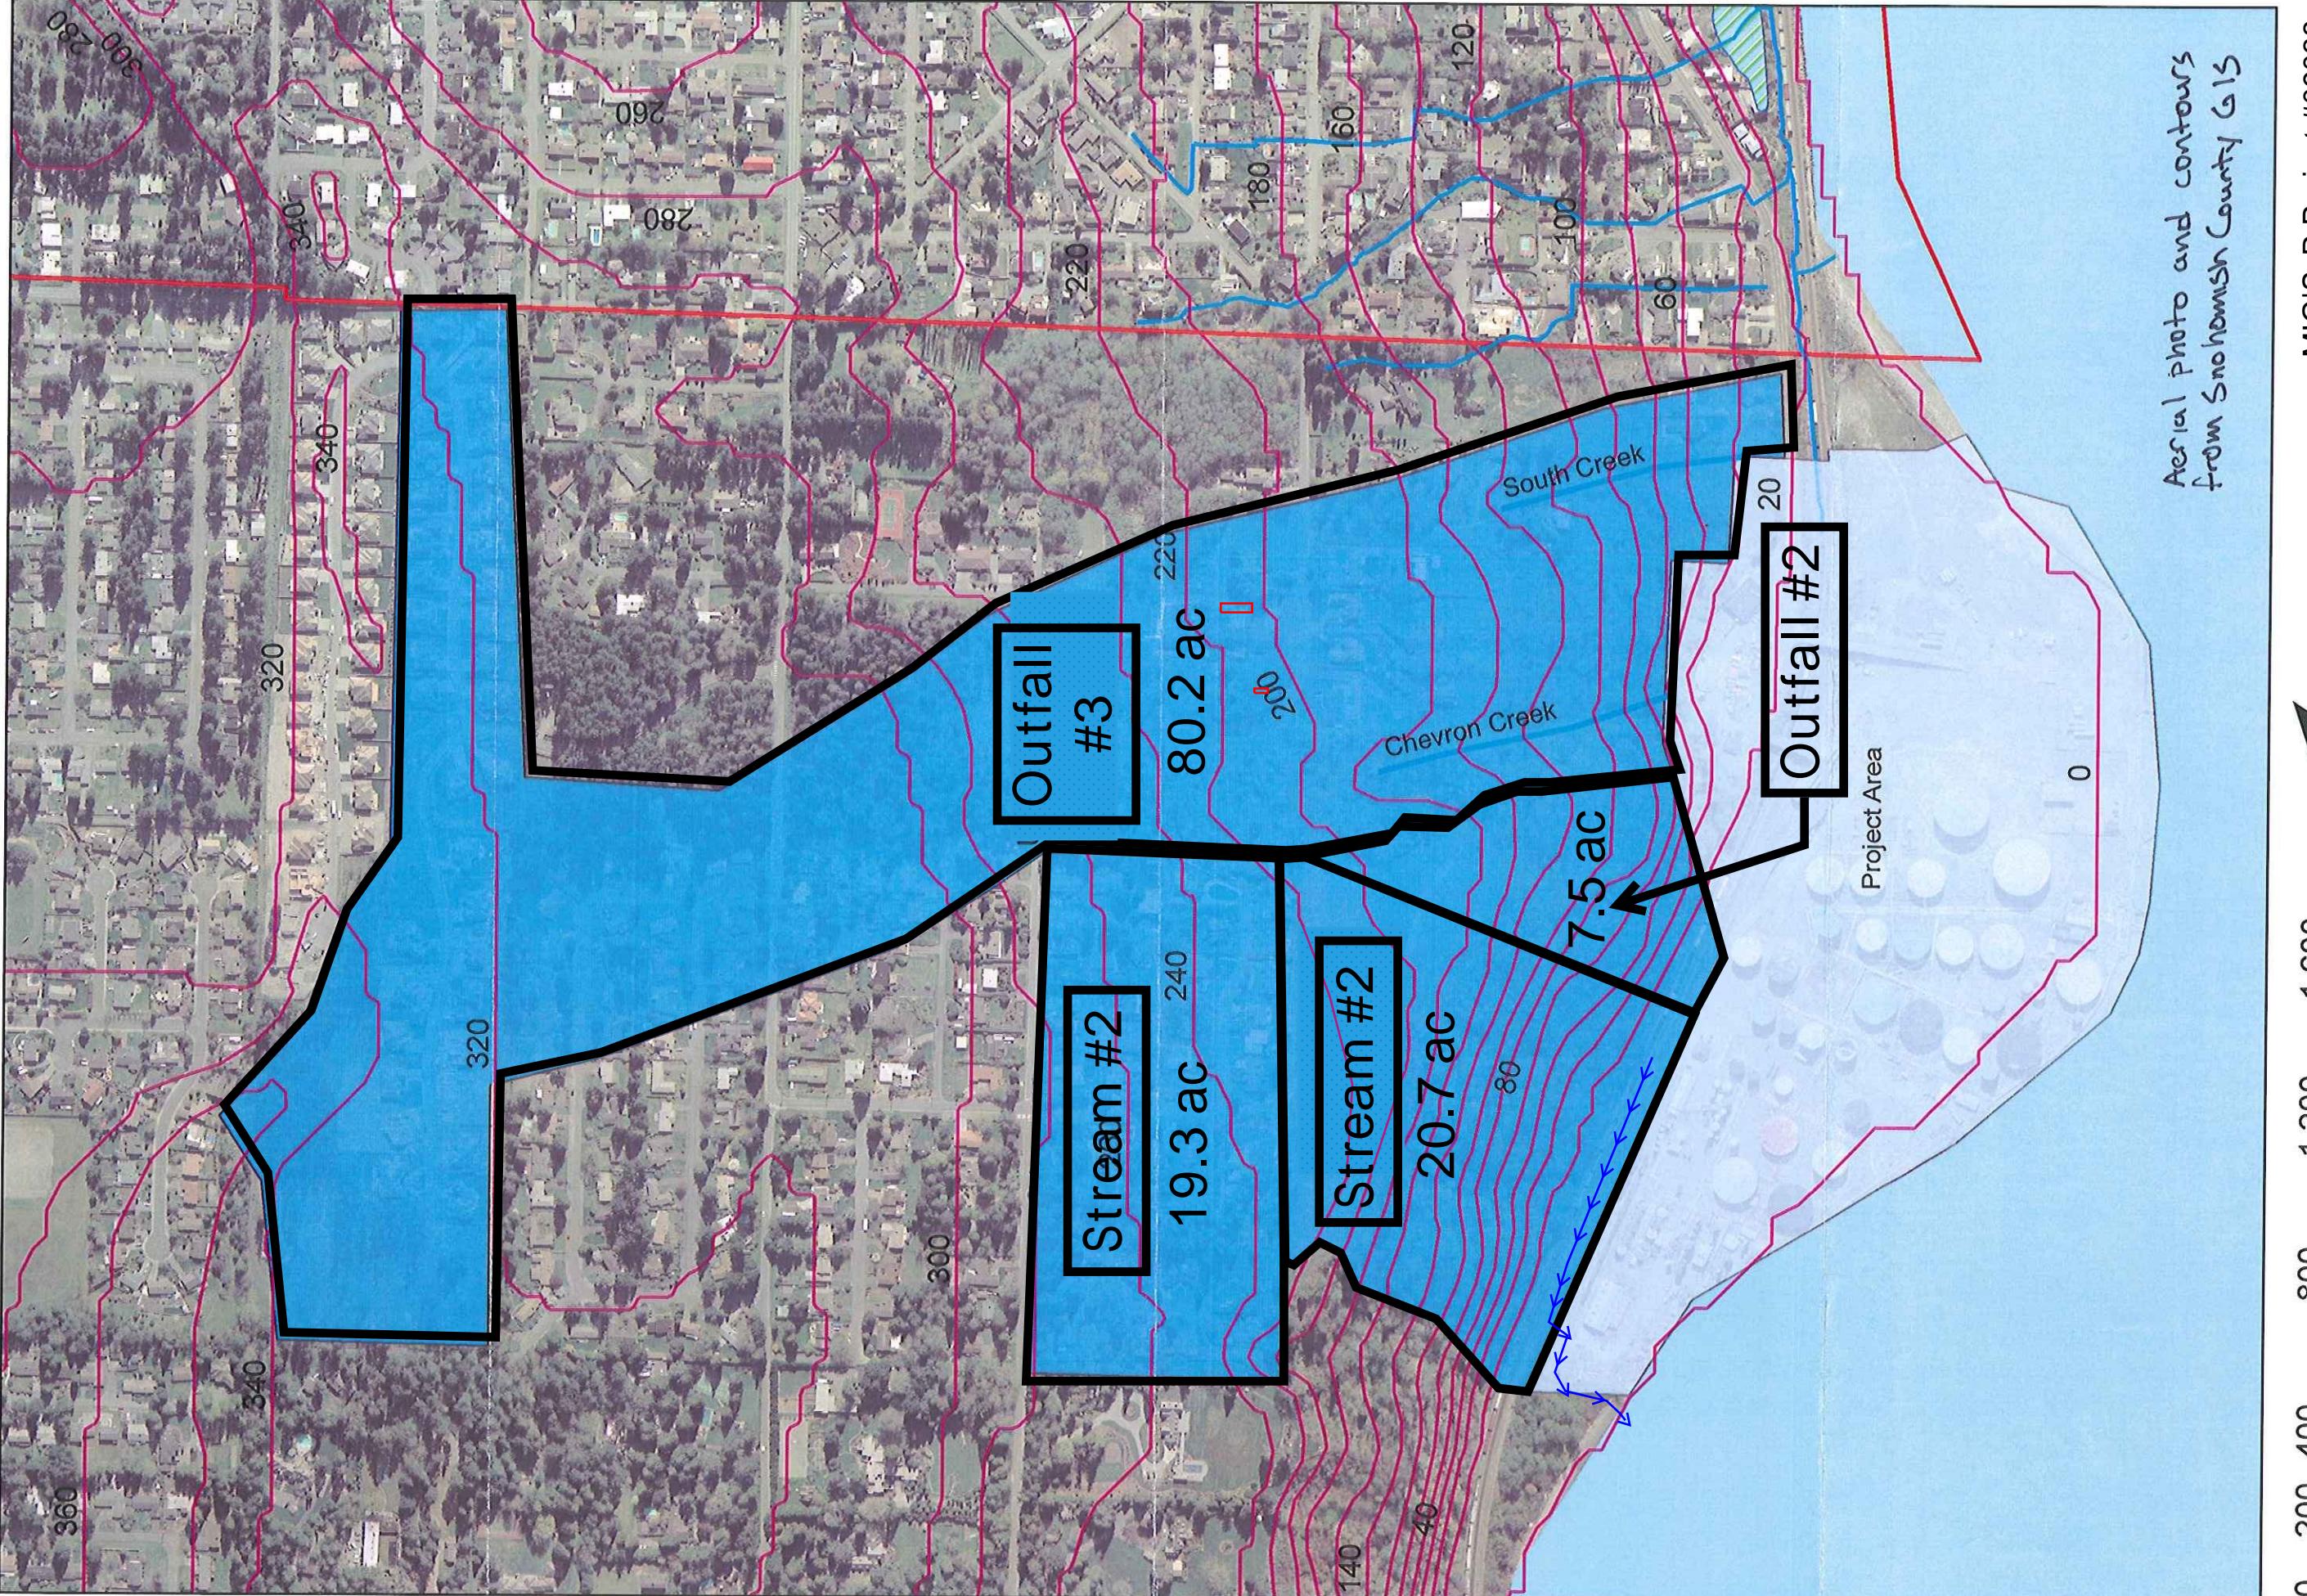
Point Wells - Upstream Drainage Basins

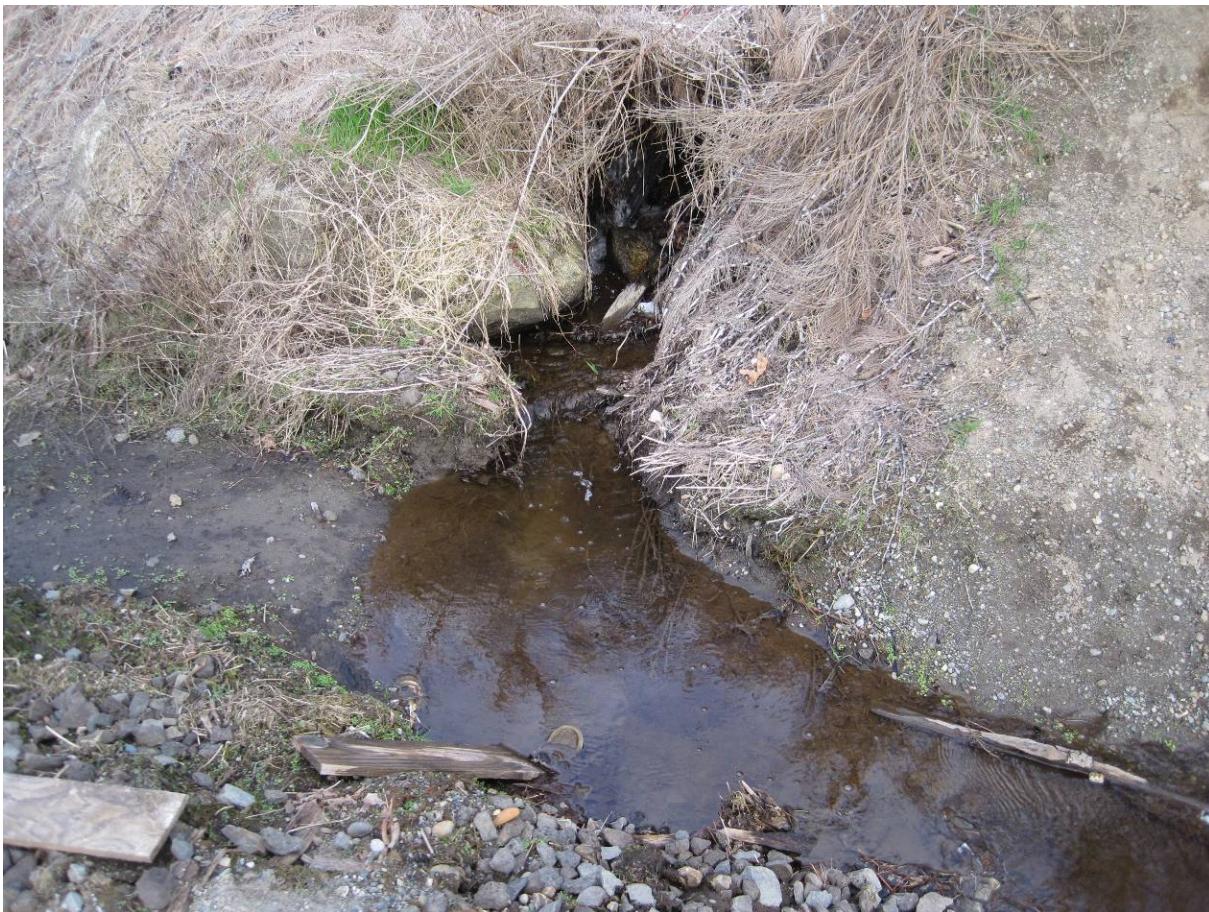
Photo 5. Discharge to east side of BNSF Railroad

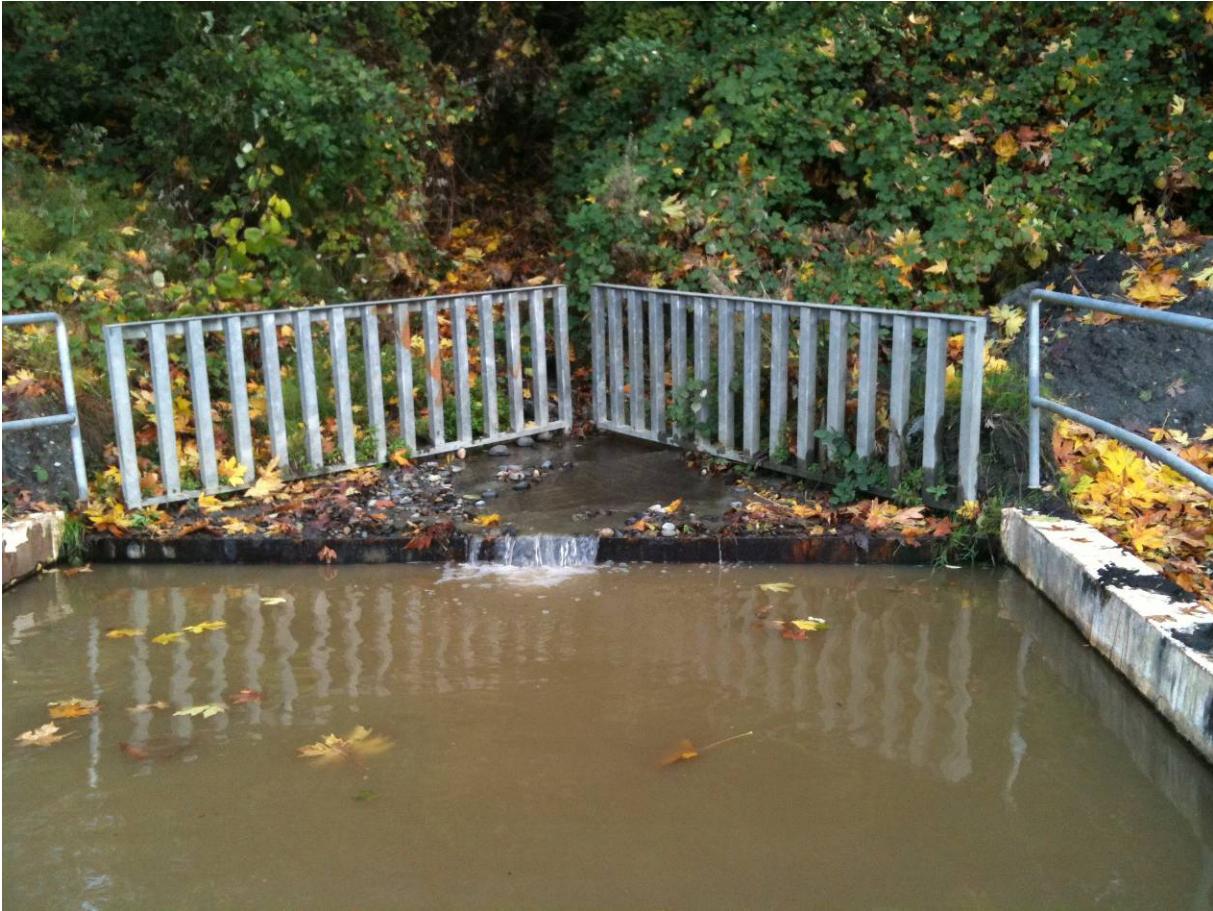
Photo 6. Chevron Creek Sediment Basin prior to Conveyance Pipe

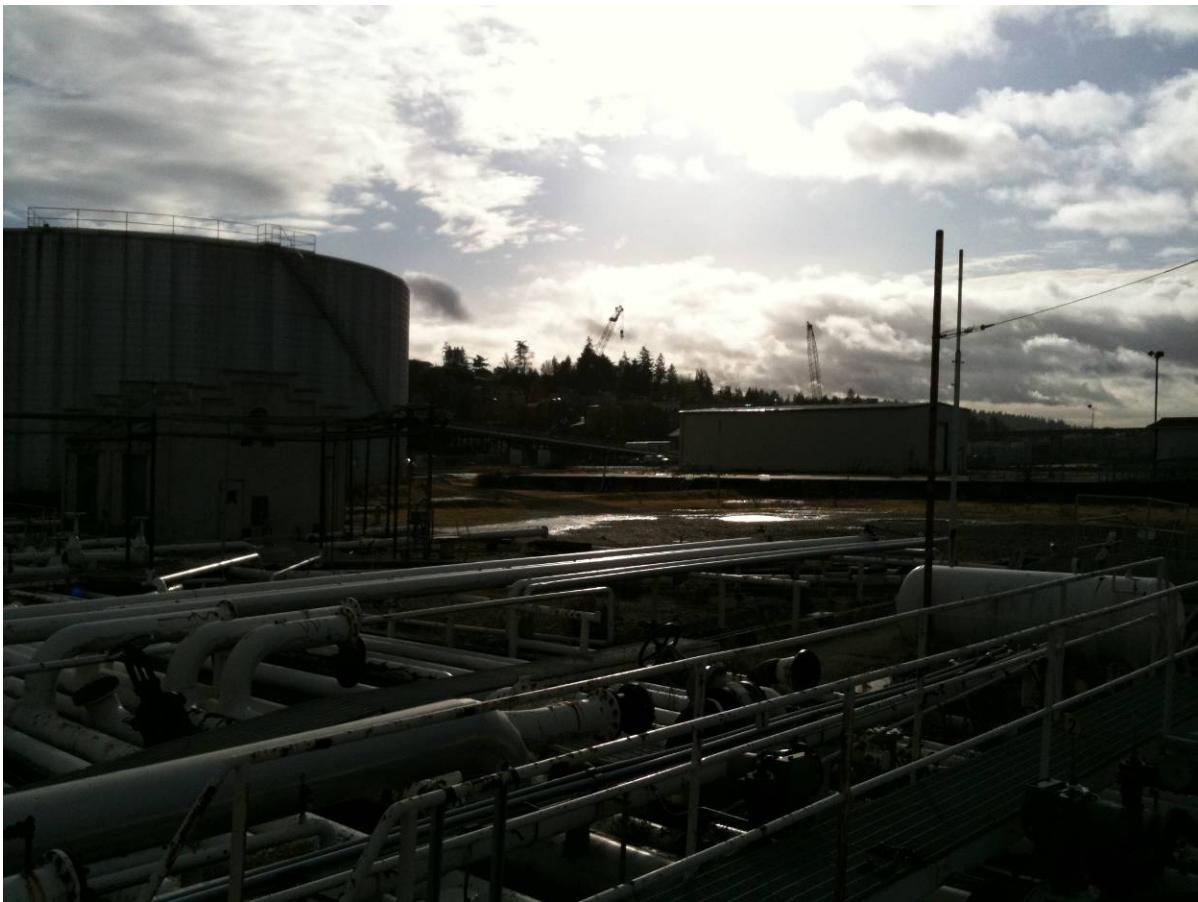
Photo 7. Point Wells Northern Petroleum Plant

The west 56 acres contains a petroleum storage, asphalt processing, and distribution plant. The relatively level western area is mostly impervious and consists of several buildings, petroleum storage tanks, roads, and parking lots (see photos in Appendix C). There is also a pier off the west edge of the site. A two-lane bridge currently accesses the west lowland. There is also another bridge to the north that is currently not operational. Both bridges are scheduled to be replaced with the proposed development.

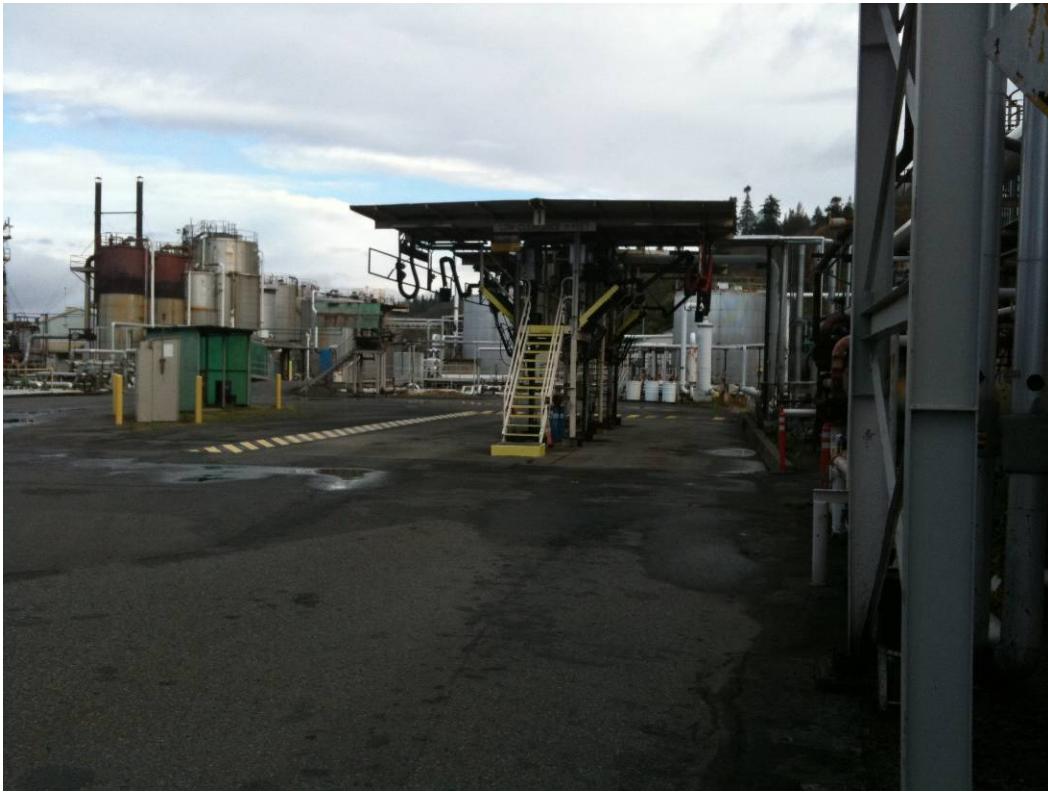
Photo 8. Point Wells Northern Asphalt Plant

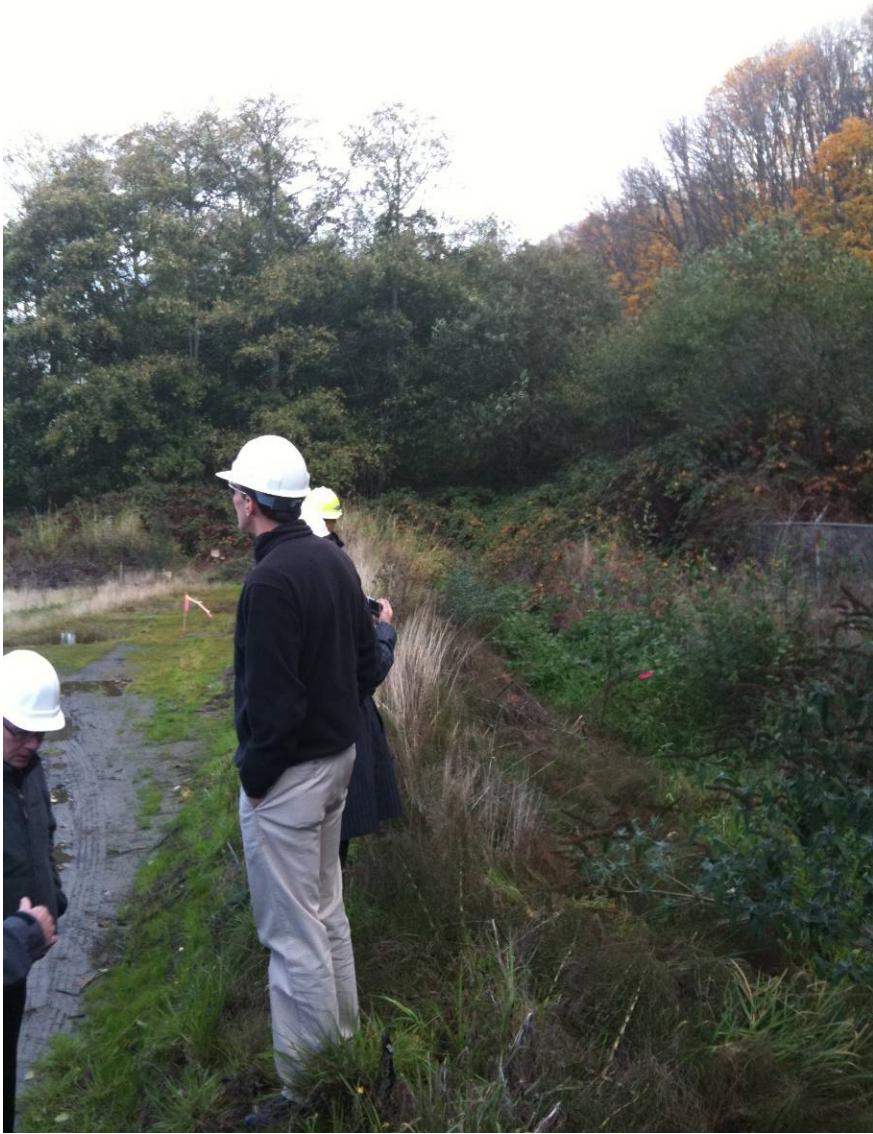
Photo 9. Point Wells northern ditch west side of BNSF Railroad

In the interim condition, the upper bench will continue to discharge to outfalls 2 and 3. The access drive to lower bench will be re-routed to discharge to outfall 2, and the northern portion of the site will be temporally re-routed to an existing drainage ditch, which discharges to Puget Sound.
